# **Pre - Case Study**

# **Treuddyn Enveloping Scheme**

Client: Flintshire County

Product: Structherm

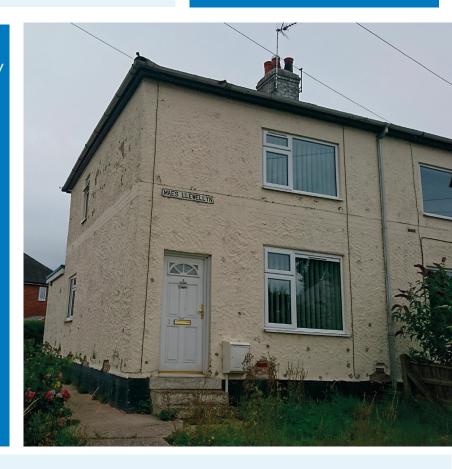
The existing cavity wall ties of the properties had failed due to corrosion. Which in turn had caused cracking in the render leading to extensive damage.

In addition to the corrosion of the wall ties, the cavity wall insulation had failed and been extracted. Cavity wall insulation can lead to trapped moisture, cold spots, condensation and mould. Failure can occur for a number of reasons including:

Considering the nature of the damage, Structherm's recommendation was to install their Structural External Wall Insulation system. Each panel includes a core of rigid insulation set within a galvanised steel welded wire space frame. These frames compose of a series of warren trusses interconnected by vertical and horizontal wires.

The stability of this product ensures there would be no need for existing wall ties to be removed or isolated. The structural stability of the panel ensures any further movement will not cause future cracking

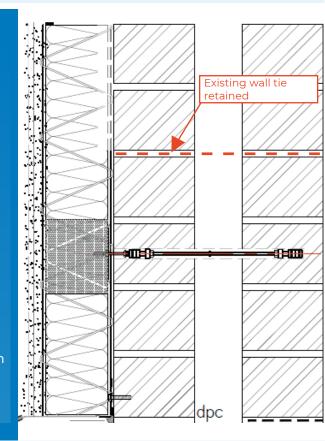
With the use of mechanical ties, the structural insulation panels are attached with only two fixings per square metre. This approach means there will be significantly less drilling and disruption to the external wall.
