Dotcliffe Road,
Kelbrook
Lancashire

Sector: Social Housing
Low Rise
Refurbishment

Client:
Housing Pendle

Building Type:
Airey

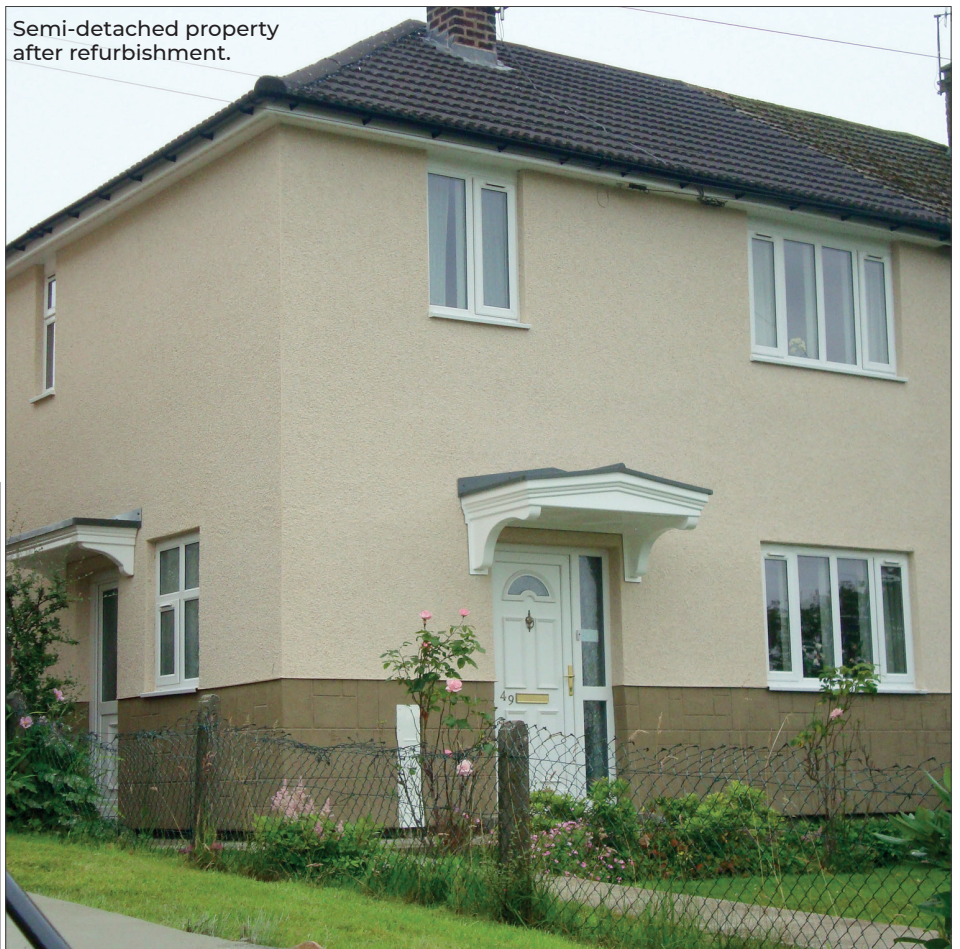
Semi-detached property
after refurbishment.

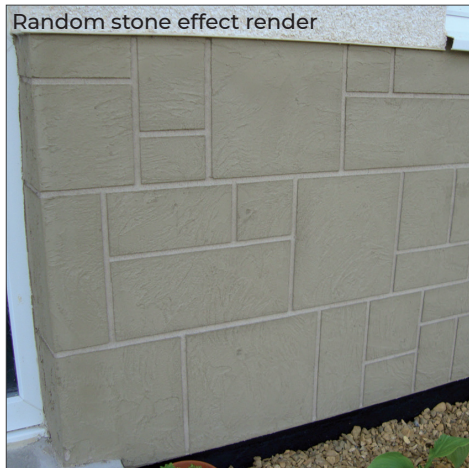
Random stone effect render

Structherm's unique Structural External Wall Insulation (SEWI) system incorporating 105mm thick Enhanced EPS insulation was specified for the external refurbishment of the properties. To complete the system a random stone effect render was applied to the lower ground floors in Old Yorkshire Stone with Keighley Grey mortar. The first floors were then finished in a Beige dash aggregate onto a York Sand dash receiver to significantly improve the appearance of the properties.

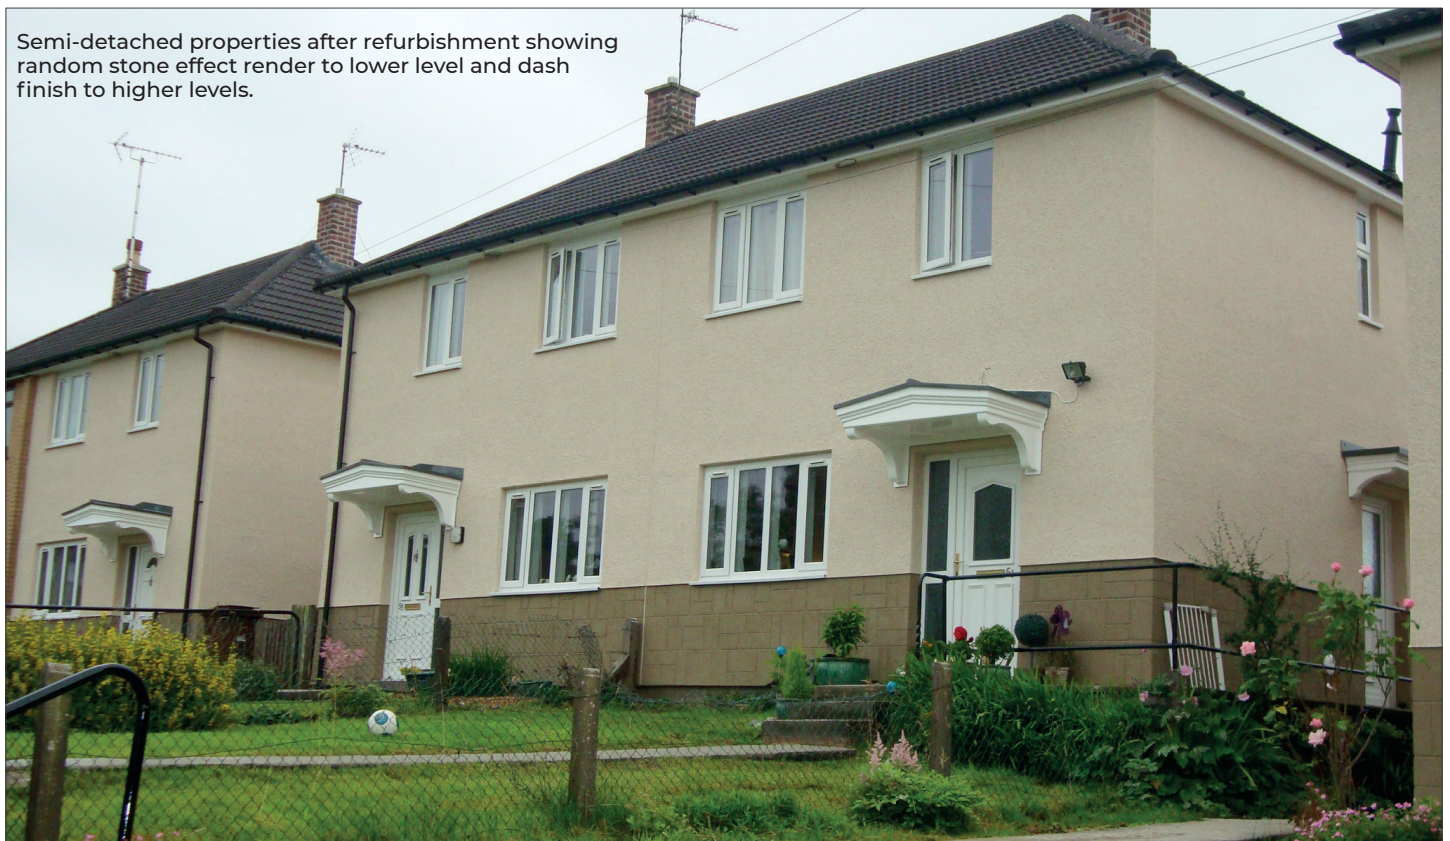
Semi-detached properties after refurbishment showing random stone effect render to lower level and dash finish to higher levels.
