Linden Road,
Cotteridge
Birmingham

Sector: Social Housing
Low Rise
Refurbishment

Building Type:
Dorlonco

Product:
Structural Insulated
Cladding
& Render Finish

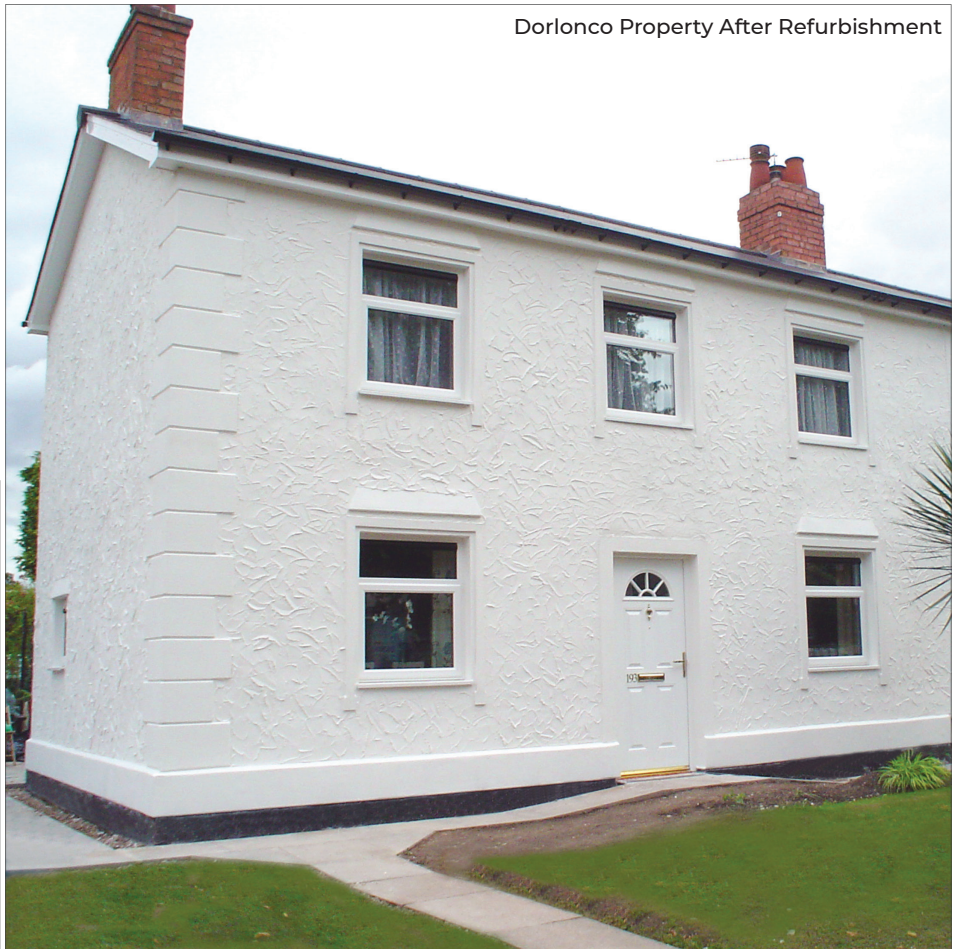
Dorlonco Property After Refurbishment

To replicate the original finishes and features, an ingenious combination of products was adopted. For the flat monochrome finish FlessCoat Cortina TH Normale acrylic render was used and for the rough trowelled effect a dash receiver over coated with two coats of FlessCoat Superfine paint was applied. For the quoins, plinths and window head details, profiled polystyrene was rendered into the façade and then painted with FlessCoat Superfine paint. This clever approach to the finish has proved to be highly successful in replicating the original features and satisfying both the planning department and the residents.

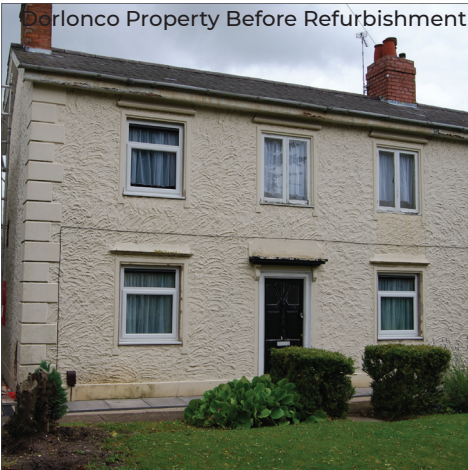
Dorlonco Property Before Refurbishment

These particular properties did not have a solid outer wall, instead heavy duty expanded steel lathing spanned each steel column to which a concrete skin was applied and then a rendered finish. It was this outer skin that was beginning to fail due to movement in the building. Cracks had appeared which then allowed water to ingress and corrode the steel lathing as well as parts of the steel frame.

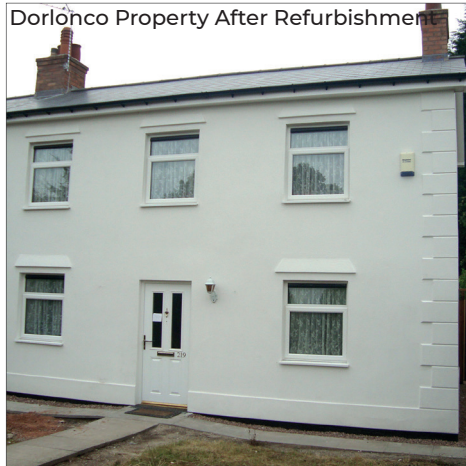
Dorlonco Property After Refurbishment

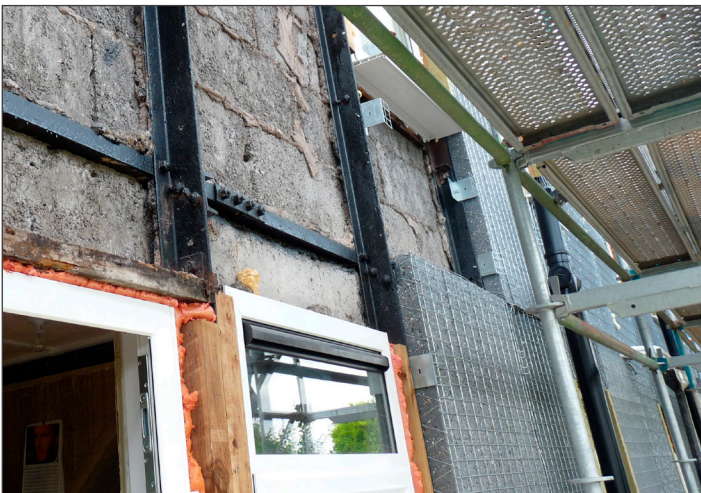
Shear receiver brackets and structural insulated cladding panels being installed between the steel columns of a stripped Dorlonco property.

The failing outer render, concrete skin and steel lathing were removed to fully expose the steel frame. Appropriate repairs and replacements were carried out to rectify the corrosion.

Structherm's unique Structural Insulated Cladding system incorporating 80mm thick Enhanced EPS was then used to span between each steel column providing a rigid, continuous envelope around the properties with real structural integrity and excellent thermal performance. The setting out and positioning of the shear receiver brackets on each column was accurately calculated so that a straight line would be achieved on every elevation, overcoming the problem of undulating walls and protrusion of the plinths.
